DART SERVICE INSTRUCTION

TO AMEND INSTRUCTIONS FOR CONTINUED AIRWORTHINESS ICA-D412-694 REV.1 OR LATER APPROVED REVISION

The purpose of this Dart Service Instruction (DSI) is to provide a procedure for repairing the damage on the D412-694-011 Spacedoor Kits removed from Bell 412EP S/N 36516 and S/N 36563.

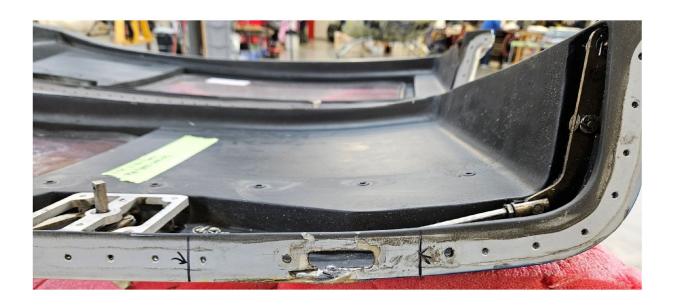
For areas of the doors with damage to the latching areas similar to Figure 3, repair as follows:

FIGURE 3: DOOR LATCH REPAIR

- 1) Remove the D3144-X doublers and D3116-5-0680 seals that are installed on the aft edge of the D412-694-03/-04 Hinge Door Assy. Remove the D3149-1 Striker Plate and D3150-1 Guide from the latching areas of the D412-694-03/-04 Hinge Door Assy.

- 2) Sand/remove the damaged laminate on the outer surface of the door to expose the aluminum doubler in the latching area a minimum of 1" on either side of the latching cutout.

- 3) Carefully cut/remove the damaged aluminum doubler a minimum of 1" on either side of the latching cutout to leave just the inner door frame.
- 4) Fabricate 2x replacement aluminum doublers from 0.032" thick 2024-T3 aluminum.

- 5) Scuff doublers with 80 grit sandpaper and treat with alodine per MIL-C-5541.
- 6) Bond replacement doublers into place against the door frame (one on each side) using Hysol EA934NA adhesive.

- 7) Layup a minimum of 3 layers of 9 oz 7781 Cloth using Hysol 9309NA Resin over the repaired area with a 1" overlap.
- 8) Once the resin has cured, blend/sand the repaired area to create a smooth transition with the rest of the door.

- 9) Cut a 1.50" x 0.40" latch opening through the repaired area of the door using the original latch opening as a guide.
- 10) Touch up door finish in accordance with Table 5-2 of ICA-D412-694.

- 11) Install replacement D3149-1 Striker Plates and D3150-1 Guides in the latching areas of the D412-694-03/-04 Hinge Door Assy using MS24694-S56 screws, AN960JD10LL washers and MS20142L3 nuts. Install replacement D3144-XXX doublers with D3116-5-0680 seals along the aft edge of the D412-694-03/-04 Hinge Door Assy using BSP45 rivets.

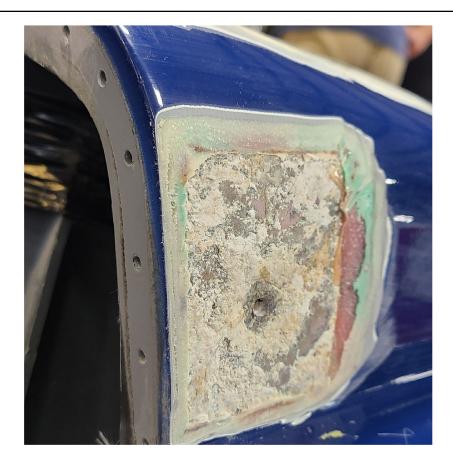
FIGURE 4: CORROSION DAMAGE (LOWER DOOR)

- **2.5.1** For corrosion damage similar to Figure 4, repair as follows:
- 1) Strip away the laminate plies above the aluminum doubler in the door.
- 2) Remove damaged doubler as shown in Figure 4.
- 3) Fabricate a replacement doubler from 0.032" thick 2024-T3 aluminum.
- 4) Scuff doubler with 80 grit sandpaper and treat with Alodine per MIL-C-5541.
- 5) Bond replacement doubler to the foam using Hysol EA934NA adhesive.
- 6) Layup a minimum of 3 layers of 9 oz 7781 cloth using Hysol 9309NA resin over the repaired area with a 1"
- 7) Once the resin has cured, blend/sand the repaired area to create a smooth transition with the rest of the door.
